## STAFF RECOMMENDATION

**SUBJECT:** Evaluation of Significance to Rockville of 19 and 20 West Montgomery Avenue

**DESCRIPTION:** Rockville Town Center, Block 4 Subdivision Lot P21

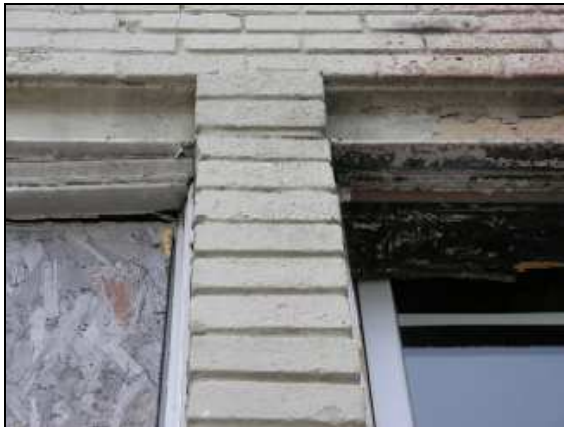
The east bay of the façade is characterized by tripartite fenestration (– w-d-w-) topped by three transoms. The central double door is a recent replacement. The brick piers that separate the windows and door openings are stacked stretcher bricks that do not follow the overall course pattern of the brick façade. These piers may be only facing material. A metal I-beam is the lintel of the openings. The windows have stone sills and the door threshold is also stone.

18 West Montgomery Avenue, façade detail

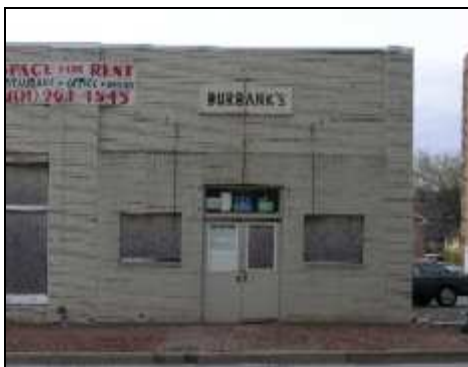
The West Bay of the façade is characterized by a two-thirds height brick infill that builds out the façade so that it is flush with the piers. Bricks used for this infill wall are more textured than the other façade bricks. An additional brick type was used to patch previous window openings on the west façade bay. The top or cornice line of the infill consists of a brick header row. The only transom is above the door and it is ½ the height of the east bay transoms. The west bay window openings are approximately half the size of the east bay windows. These windows are boarded over, but their slightly projecting brick header sills are evident. The painted metal double doors appear to be recent retail stock items. The brick wall above the infill contains numerous pieces of hardware that likely supported a variety of different signs.

West bay of facade

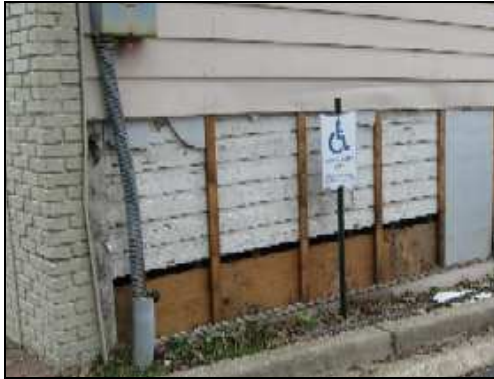
West elevation with German Siding,  
November 2007

The west elevation of the building is completely covered with recent vinyl siding. A photograph taken before the repair of the west elevation's vinyl siding indicates wood German siding underneath. The east elevation is faced with stucco. The three vinyl windows have been recently installed and are trimmed with wide painted wood surrounds.

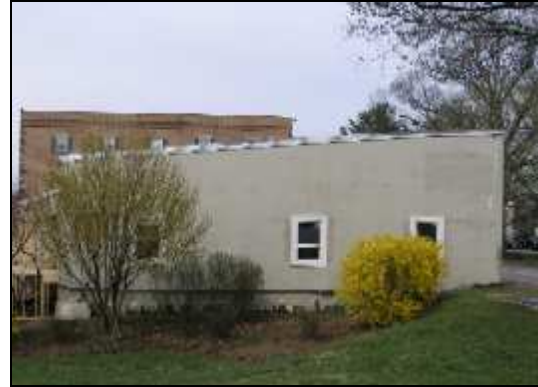
East elevation

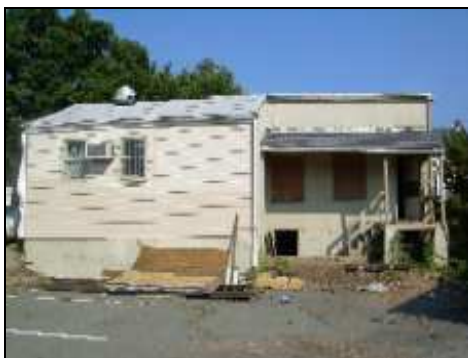
The rear of the east bay has recently been altered by an incomplete construction project. The east half of the rear elevation is recessed back from the west rear addition. Two 1/1-sash windows and a rear door pierce the wall. The pre-construction photo on the left indicates the door was fronted by a stoop with side stairs supported by cement block piers. A shed roof was located above the windows about 2' below the roof and is supported by two posts on the stoop.

Rear elevation, November 2007

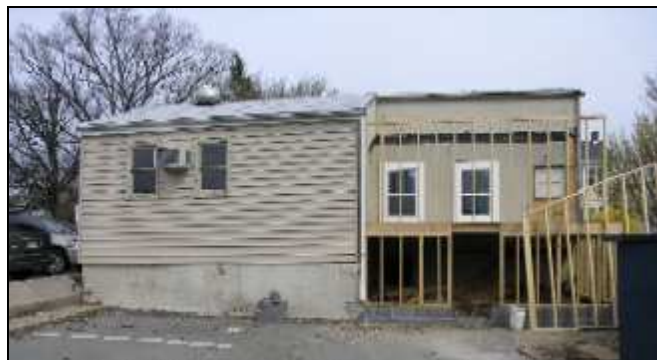
Rear elevation, current

The recent construction project has resulted in the removal of the shed roof, stairs, and stoop. A platform is built out at the door level and extends out to the rear wall plane of the west bay rear elevation. A cement block foundation has been laid under the perimeter of the platform and the back wall has been framed out. The windows have been replaced with 1/1 vinyl with wide plain board surrounds, similar to those found on the east elevation.

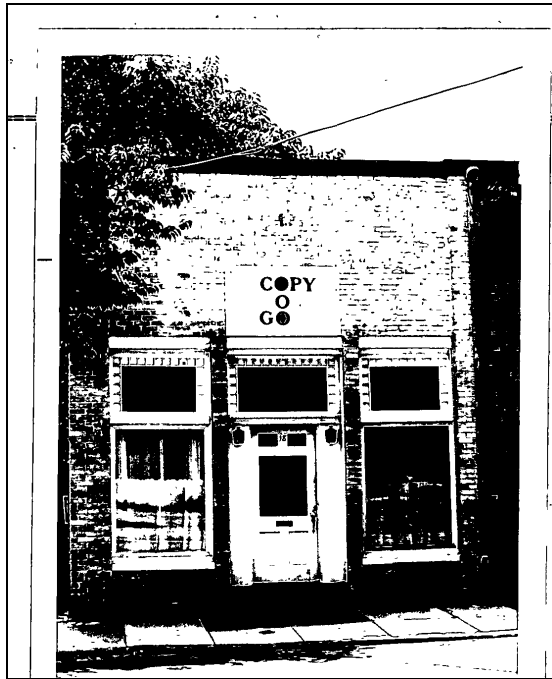
A 1976 city of Rockville Historic Building Inventory form contains a picture of the east bay of Burbanks, which was a "Copy to Go" store at the time. The image is from a scanned file and is not very clear. The Dentil Row moldings lining the inside of transom windows were probably

contemporary trim applications. The eastern window appears by divided into four rectangular lights, which could have dated from the building's original construction. The top of the building has a dark band across it, which could be a former cornice element, or only paint. The small part of the west bay in the photo is much darker, suggesting the brick façade was painted two different colors.

1976 from inventory form
